A FRACTOGRAPHIC STUDY OF THE FATIGUE FAILURE  
OF AIRCRAFT WHEELS

NATIONAL AERONAUTICAL ESTABLISHMENT

NOVEMBER 1974

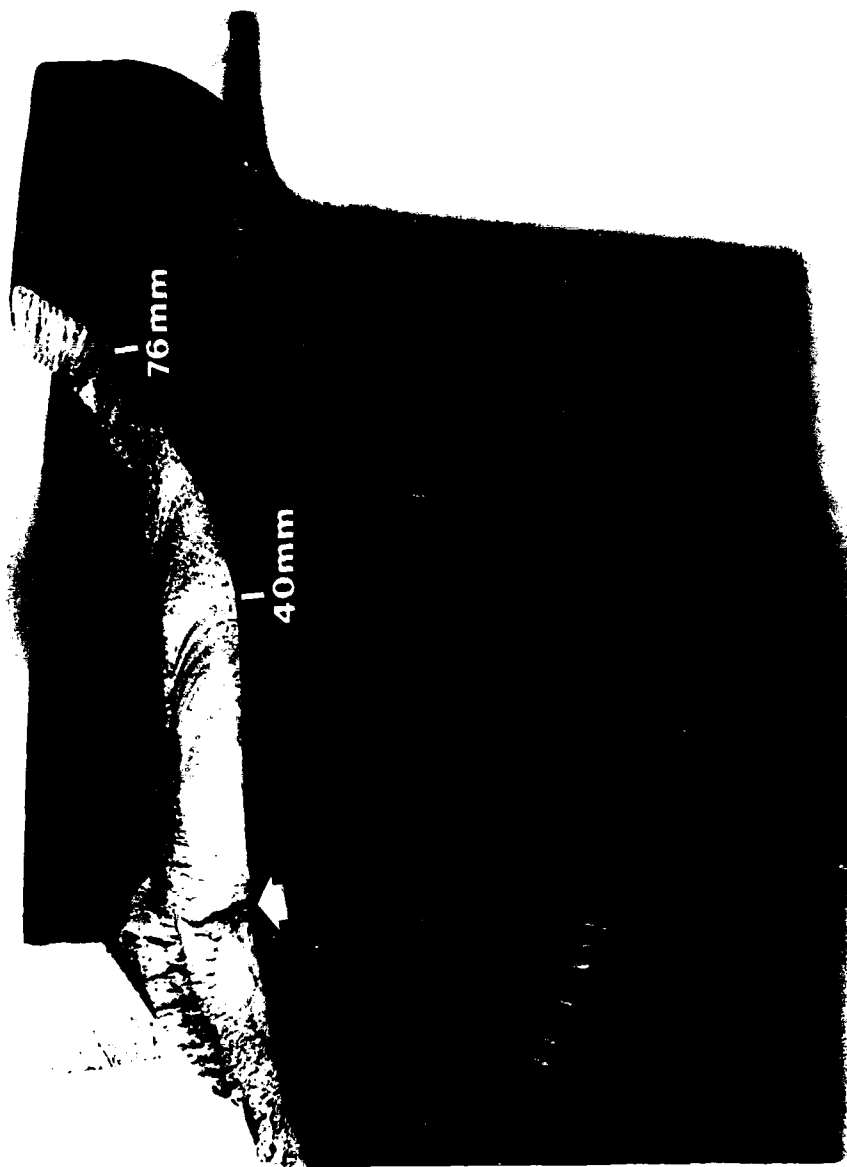
Curved macroscopic fatigue crack progression lines or "bands" emanating from the point of crack nucleation can readily be resolved on the wheel fracture surface illustrated in Figure 15. Since the validity of the following quantitative crack propagation analyses rests upon the proper interpretation of the nature of these bands in terms of the micro-mechanisms of fracture, a closer examination of the microscopic topographical features is warranted, and an attempt will be made to correlate them with certain aspects of the "landing, take-off" sequence, or "landing cycle" of the aircraft.

Fatigue crack growth information for this wheel was determined over the 76 mm. crack interval identified in Figure 15. Although the crack was initiated at a point adjacent to the bead-seat radius, crack growth occurred primarily at an angle of some 60° to the wheel radius, through the wheel flange.

FIG. 15      FATIGUE FRACTURE SURFACE - WHEEL TYPE "C"  
(ARROW INDICATES REGION OF CRACK NUCLEATION)

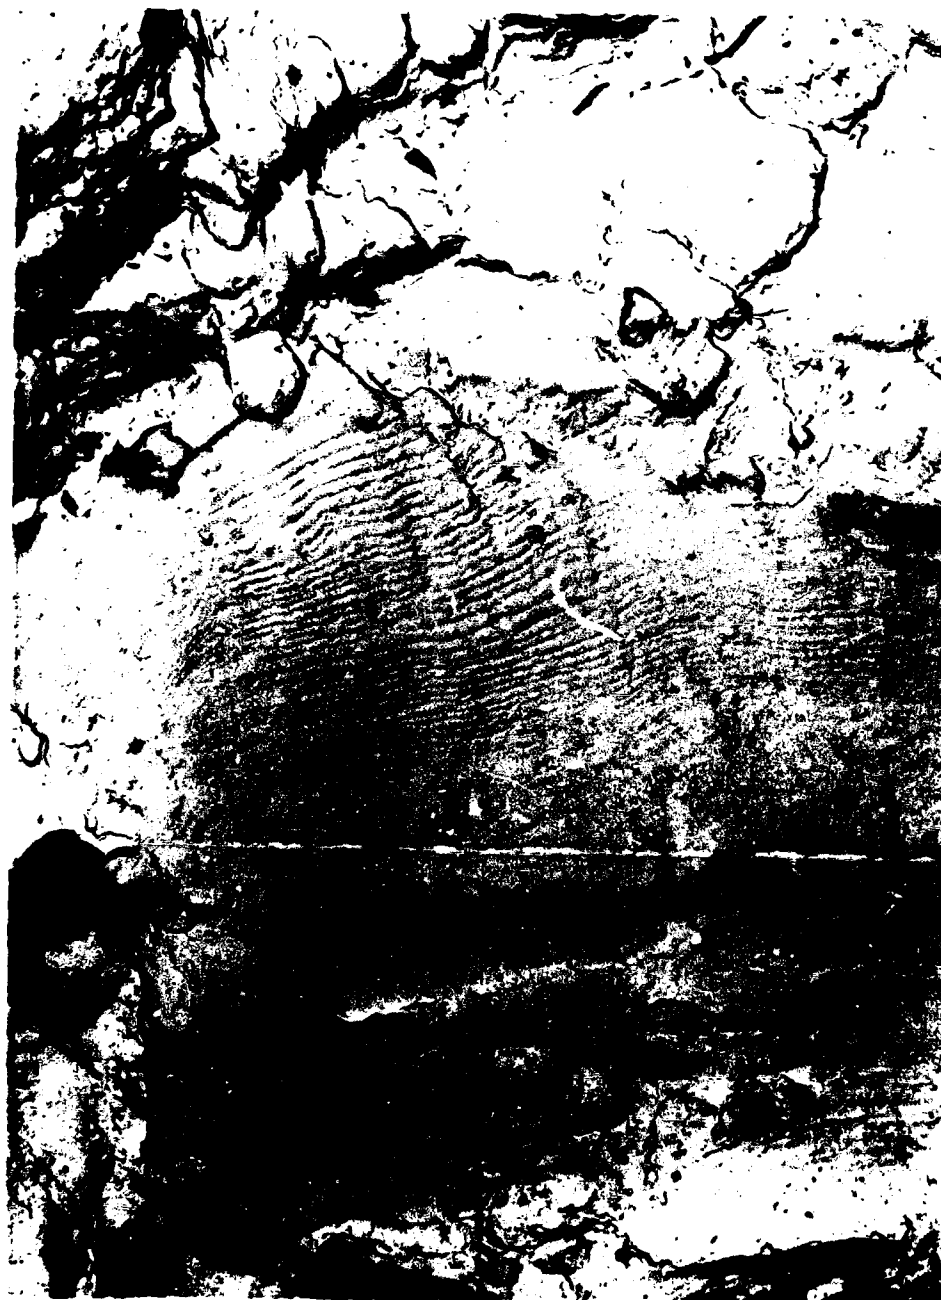
More clearly defined fracture surface topography in the form of fatigue striations and ductile dimples is illustrated in the micrograph, Figure 20, taken from a failed type "B" wheel. If the wheel rotation-striation correspondence is assumed, the count of 43 striations in this micrograph would represent an aircraft roll distance of some 500 ft. Neither this distance nor that previously estimated for the type "C" wheel would account for the estimated 5 roll miles for a typical landing cycle of a jet transport. Therefore manoeuvres such as pivoting, and brake application at high speed must be examined in an attempt to account for the relatively small number of fine fatigue striations on any one area of the various wheel fracture surfaces. Without correlative strain measurements under service conditions, no rational deductions can be made with respect to the pivoting manoeuvres.

The abundance of ductile dimples observed on the fracture surfaces of the type "B" wheels, even within a few millimeters of the crack origin, indicates zones of rapid fracture, likely due, in part, to high stress levels associated with landing impact loads.

FIG. 20 MICROSCOPIC FATIGUE STRIATIONS AND DUCTILE DIMPLES  
WHEEL TYPE "B"
